TECHNICAL NOTE 3973

ORIGIN AND PREVENTION OF CRASH FIRES IN TURBOJET AIRCRAFT

By I. Irving Pinkel, Solomon Weiss, G. Merritt Preston,
and Gerard J. Pesman

Lewis Flight Propulsion Laboratory
Cleveland, Ohio

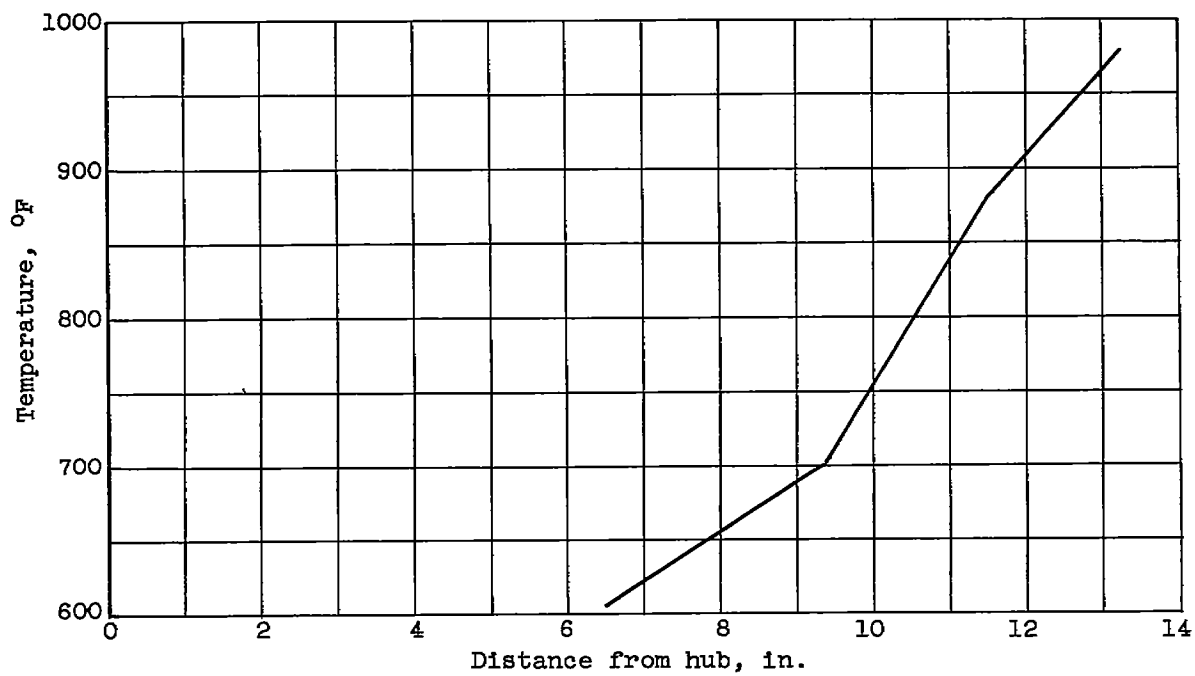
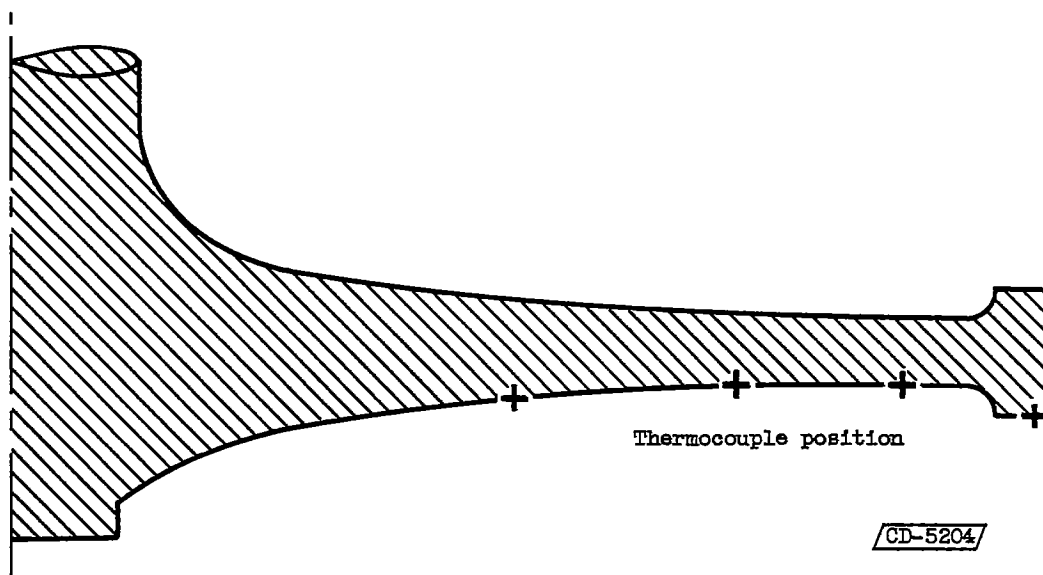
Figure 28. - Maximum temperatures recorded on J47-engine turbine wheel.

Engine parts not in the main gas stream were heated mostly by conduction. The turbine wheel was the most massive engine part heated this way. The radial variation in temperature on the surface of the turbine wheel, shown in figure 28, resulted from the fact that the heat conduction was from the wheel rim to the relatively cool hub. The data shown were obtained with the engine operating at rated sea-level conditions. The turbine-wheel surface temperature varied from approximately 980° F at the rim to about 605° F at a point midway between the rim and hub. Cooling air from the compressor applied to the hub to protect the engine bearings maintained this temperature pattern.

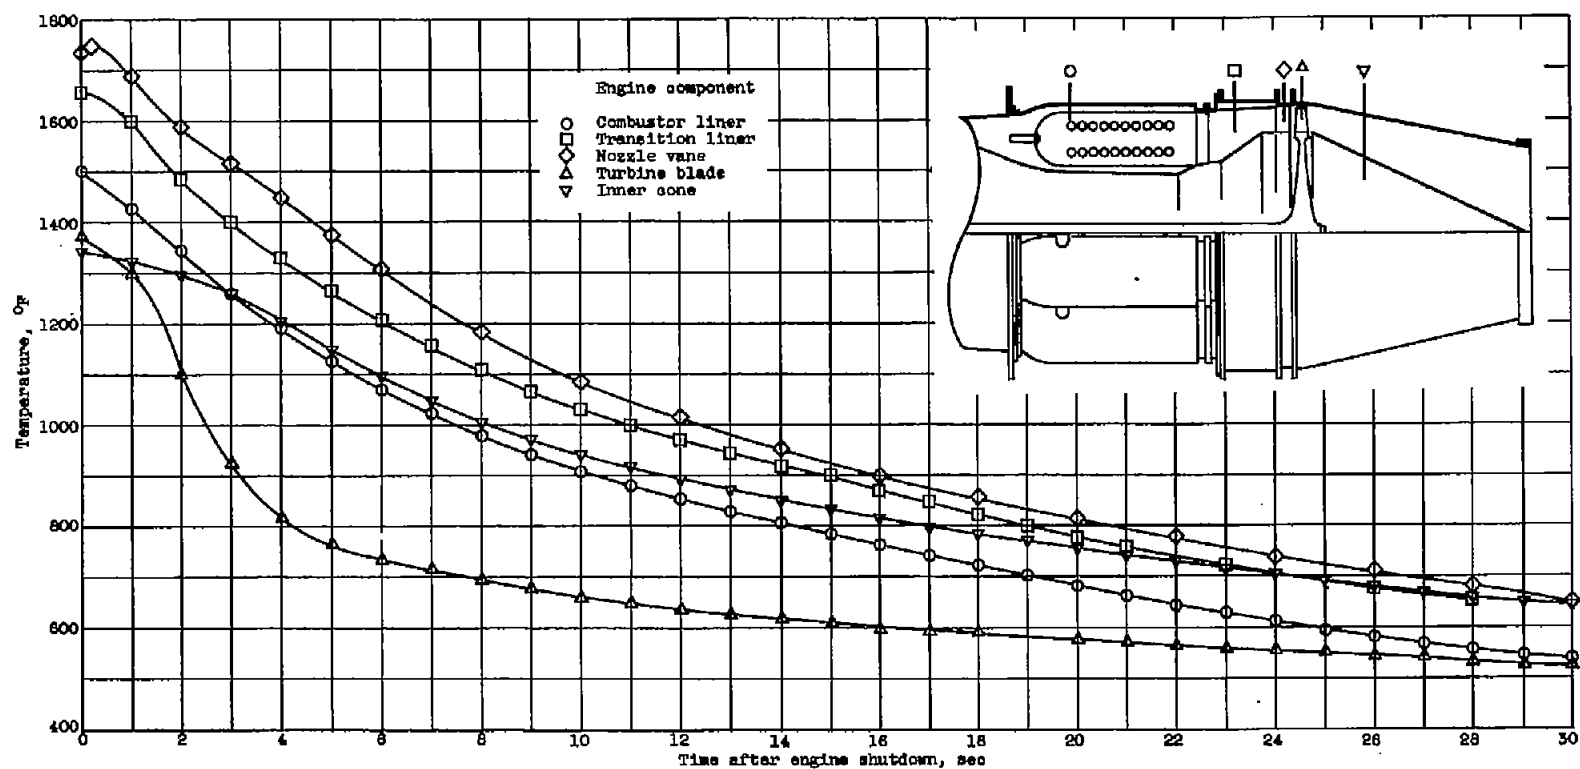
Figure 29. - History of maximum temperatures on engine components in main gas stream.

A history of the temperature of engine parts lying in the main gas stream is shown in figure 29. Fuel shutoff occurred at zero second, and the temperatures indicated were the maximum recorded anywhere on the component at the time noted. The hottest section of the combustion-chamber liner cooled from 1500° to 600° F in $24\frac{1}{2}$ seconds. It took over 30 seconds for the transition-liner temperature to decline from 1660° to 600° F. In 30 seconds the turbine nozzle-vane temperature dropped from a maximum temperature of 1750° to 645° F. The rotating turbine blade temperature fell from 1370° to 600° F in 16 seconds. Inner-cone skin temperatures declined from 1340° to 640° F in 30 seconds.

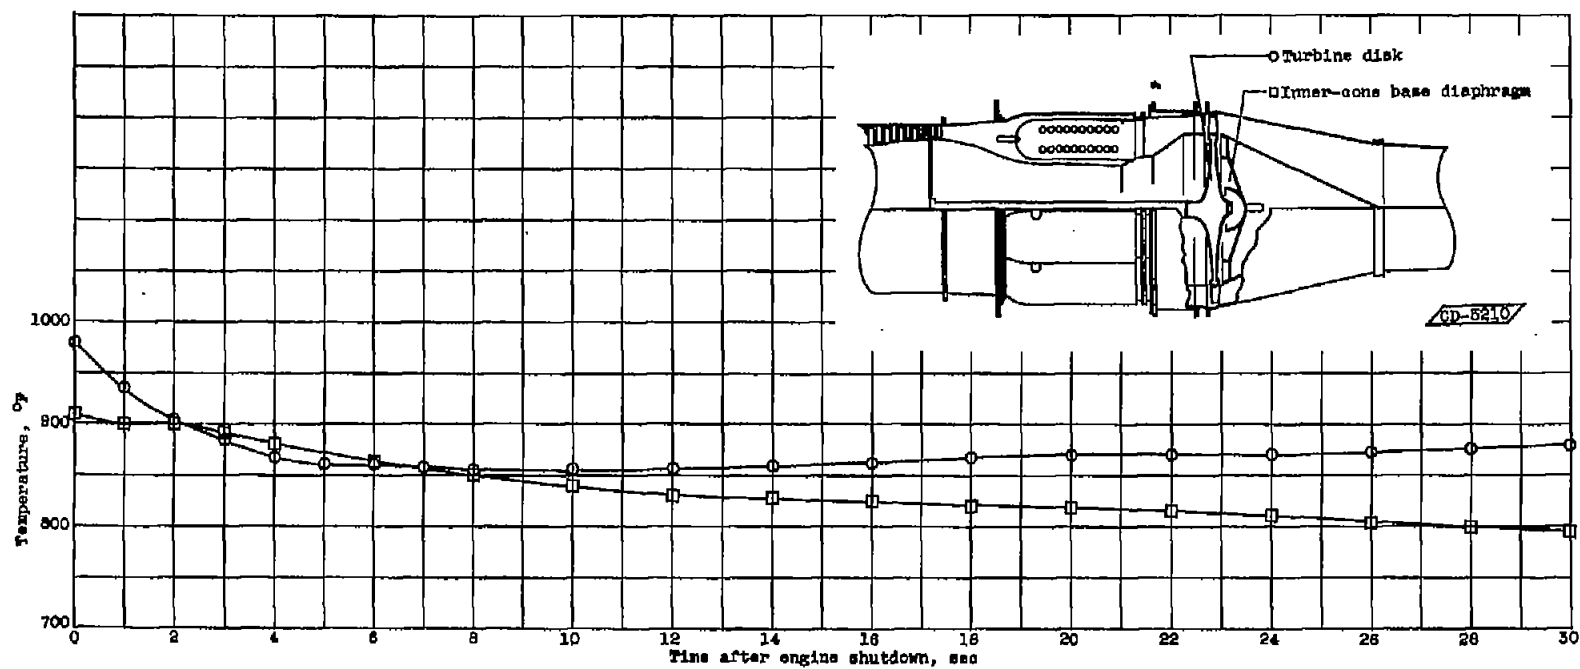
Figure 30. - History of maximum temperatures on turbine disk and inner-cone base diaphragm.

Engine parts not located in the main gas stream declined in temperature at much slower rates (fig. 30). The hottest part of the turbine wheel was initially at 980° F and dropped only 100° F in 30 seconds after fuel flow to the engine had stopped. The turbine wheel remained above the ignition temperature of JP-4 fuel for 30 minutes after the engine was shut down. The large mass of the turbine disk contributed to its slow cooling rate. The inner-cone base diaphragm exhibited the same slow rate of cooling. Its maximum temperature was 910° F and cooled only approximately 115° F in 30 seconds.

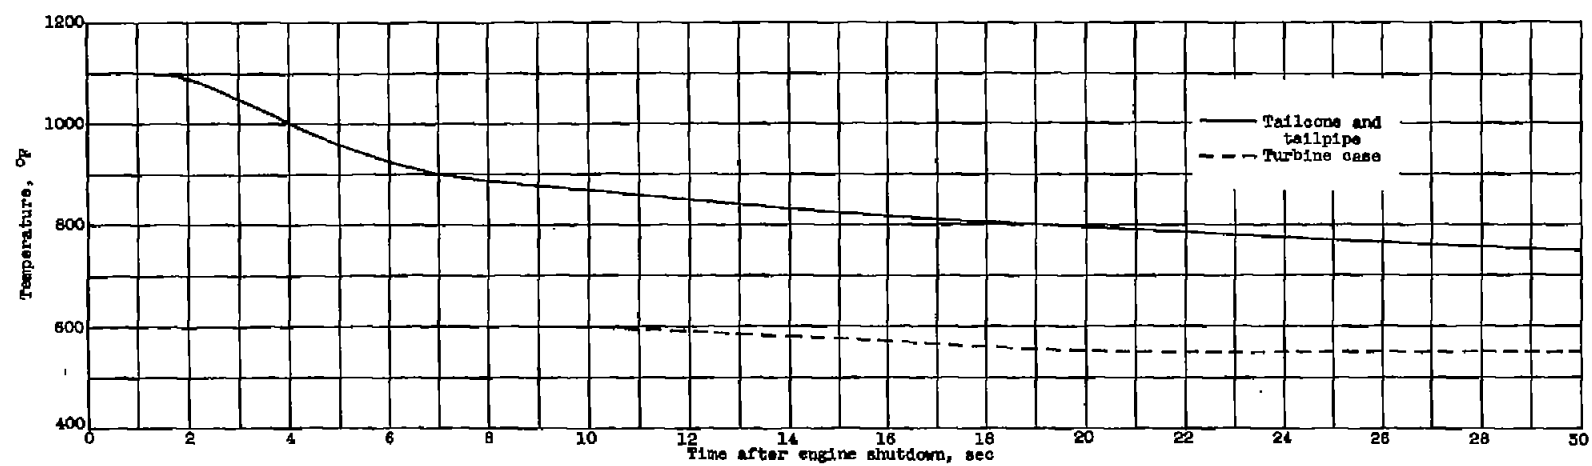
Figure 31. - History of maximum external skin temperatures on J47 turbine case and tailcone and tailpipe.

Temperature measurements made on the external skin of the J47 engine (fig. 31) indicated that the tailcone and tailpipe temperatures remained above 600° F for more than 30 seconds after the fuel to the combustor was shut off. Temperatures of the engine case upstream of the tailcone and tailpipe were usually below 600° F (fig. 32). Although the turbine case reached a maximum temperature of 600° F and remained so for 10 seconds after the fuel was shut off (fig. 31), no ignitions were experienced here.
